Degradation in the Papillion Creek Watershed: Predicting, Preventing, and Planning

Prepared by: Paul Boyd, Lead Hydraulic Engineer – Omaha District

Presented to: Omaha Sediment and Erosion Control Seminar

Date: 10 February 2022

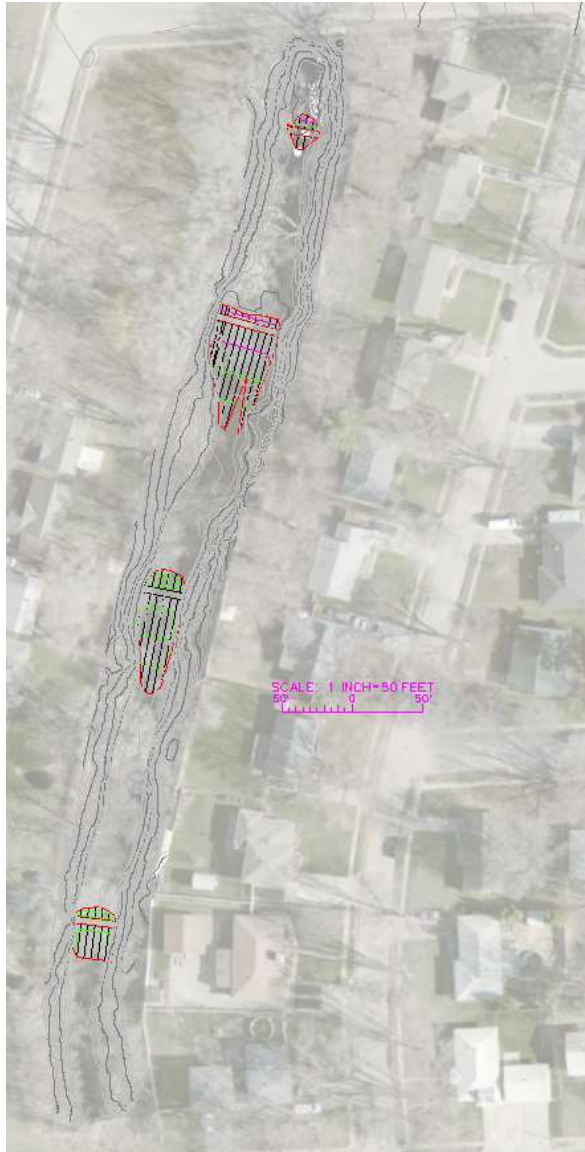
EXAMPLE QUANTITIES AND LAYOUT – COLE CREEK RIFFLES – HILLSIDE DR TO SEWARD ST. – EXPANDED TO WESTERN TO BLONDO

Station (ft)	Elev (ft)	InRoads Fill Volume (CY)	Tonnage Volume (TON)	Foundation Thickness (FT)	Foundation Tonnage (TON)	Key Tonnage (TON)	Total Tonnage (TON)	\$/ton	\$
GCS #1	5610	1043.2	30	49.5	3	194	18	262	80	\$20,973
GCS #2	5850	1044.6	140	231	3	411	18	660	80	\$52,800
GCS #3	6050	1045.8	120	198	3	528	18	744	80	\$59,547
GCS #4	6200	1046.6	10	16.5	3	70	18	105	80	\$8,360
							SUM	1771		\$141,680

- Concept Quantities developed utilizing available .dtm and 3D modeling.
- Less robust data sources in other reaches will require more empirical estimates
